Quest Engineering & Failure Analysis, Inc.
www.quest-engineering.com

Re: Rebuttal Report

File: Bryson Accident
Quest No: 10519

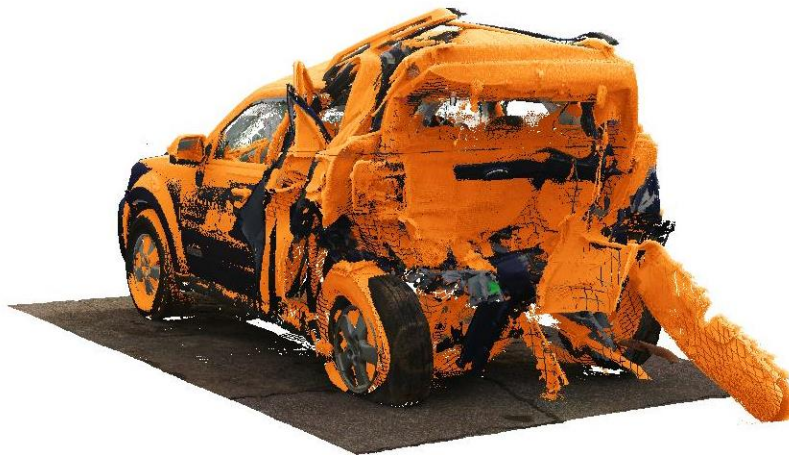
An analysis was performed to verify if there actually was more crush in the **test** than the **accident** Escape, as opined by Grimes (deposition page 210). The 3D scan of the **accident** Escape and the **test** Escape were overlaid using the undamaged front end of the vehicle. Then, cross sections of the both vehicles were taken at eight elevations and were compared. The analysis revealed that relative to the child location, there is more crush on the **accident** Escape at every elevation. *Figure 1* shows the **accident** Escape scan (black) and **test** Escape scan (orange) overlaid. Because the **test** Escape's orange color is more visible, it is more exposed and thus has less crush than the **accident** Escape.

*Figure 1: 3D overlay of the **accident** Escape (dark) and **test** Escape (orange)*

Further, the frame of the **accident** Escape (green tape identified) protrudes beyond the **test** vehicle, concretely demonstrating the override in the accident vs the non-override in the test. Directly behind the rear seat occupant's position, the test had 9 inches less crush.

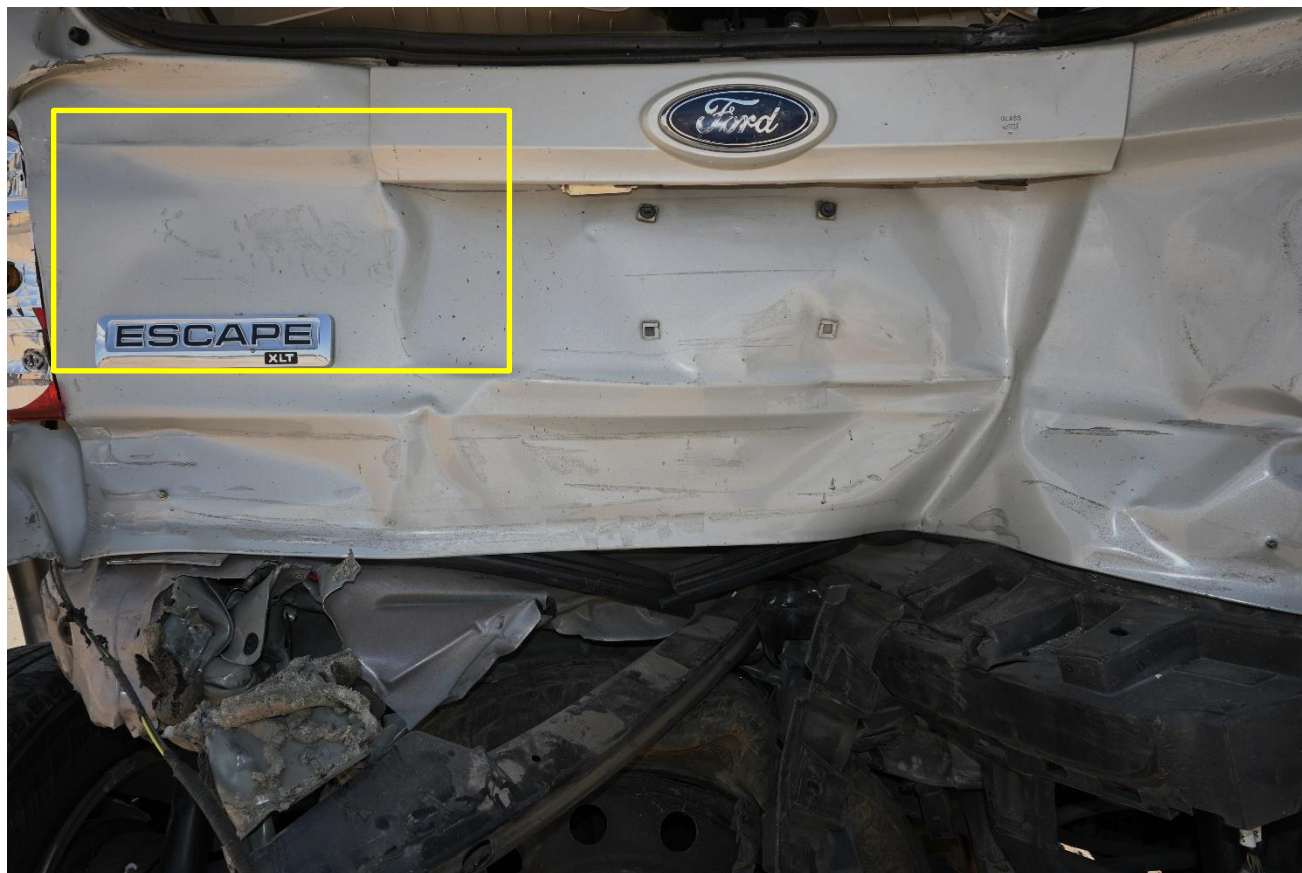
Exponent and Grimes failed to properly record the **test** offset as outlined above, and Grimes states that a **test** offset variance of 5 inches from the **accident** offset will make a difference (deposition page 184). Quest has performed three separate analyses to determine the **test** vehicles' offset compared to the **accident** vehicles offset and we have discovered a variance of 5 inches \pm 1 inch. We should not have needed to perform this analysis because in standard crash testing, the offset should be sufficiently recorded by the test facility and verified by the reconstructionist. Quest discovered the discrepancy because the Ford logo on the striking F250 left imprint marks on both the **test** and **accident** Escape. These logos are displaced laterally 5 inches \pm 1 inch from each other, meaning that the **test** F250 missed hitting the **test** Escape in the proper location. Since the **test** F250 hit to the left of the accident location, there was less width of the **test** Escape available to resist the **test** F250 and therefore the resulting **test** Escape crush would have been amplified. Thus, again, the test is not an adequate basis for Grimes to use for his opinions. The Ford logo imprints are shown in the following two photographs (*Figure 3*). Crosby confirmed the presence of the logo imprint whereas Grimes did not remember it.

Of the three methods Quest used to determine the **test** offset, two of the three used the logo imprint and one used crash test video (*Figure 3*). For this crash test to be repeatable, a proper crash test methodology would have needed to be performed to establish readily identifiable markers to record that the crash test struck the proper location consistent with the accident.

Figure 3A: Crash test photo 12327PH_0385

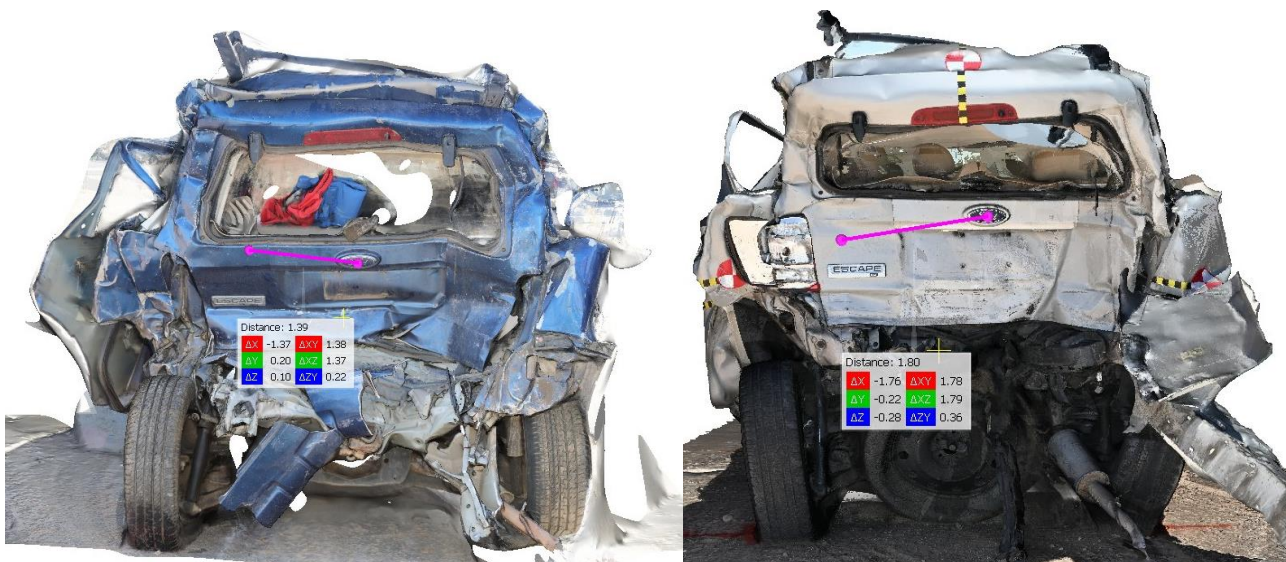
photos taken by Jeff Kidd on April 3, 2020 and the **test** Escape's imprint was visible in Exponent's crash test photos. The photos were sufficient to create a photomodel of the rear of both vehicles. The photomodels were then scaled using measurements from the scans of the respective vehicles. The imprints were then measured from the centerline of the Escape, which resulted in a difference of 4.7 inches laterally (*Figure 4*).

Figure 4: Accident Escape and test Escape photomodels with measurements from centerline to left edge of Ford logo imprint

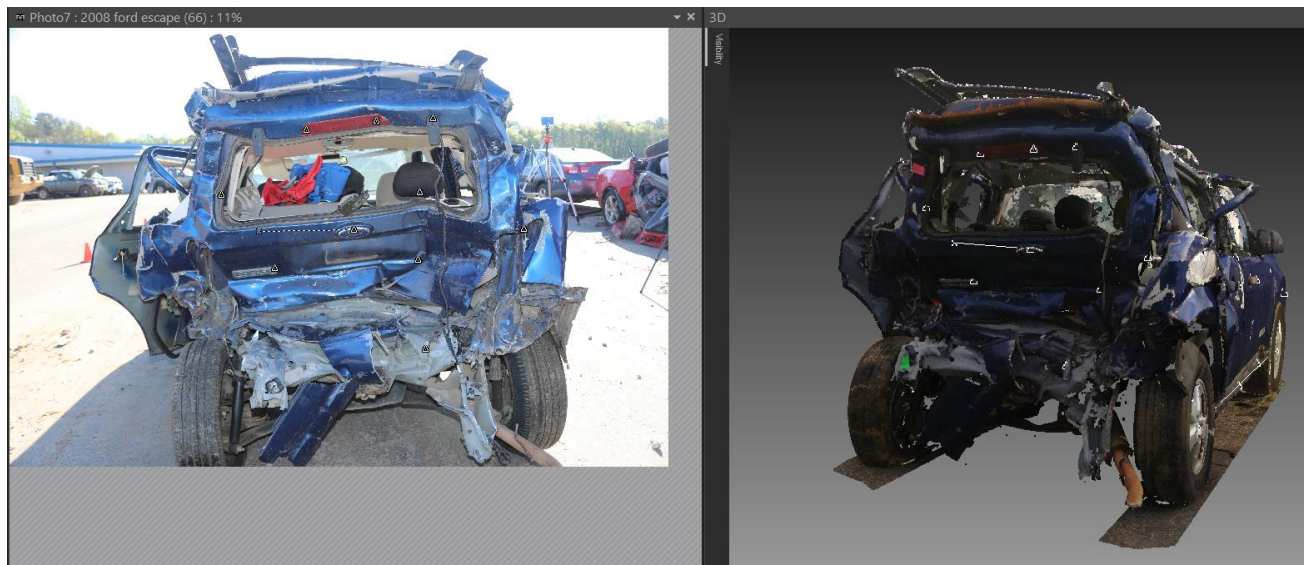
The second method used to determine the difference in offset between the **accident** and the **test** was by using photogrammetry. The imprint on both vehicles was visible in photos. PhotoModeler Premium was utilized to determine the camera parameters by correlating the 2D data with the 3D scan. After

the camera parameters were solved, the photo was measured, which resulted in a difference of 4.9 inches laterally (*Figure 5*).

Figure 5A: Photogrammetry analysis of the accident Escape

Figure 5B: PhotoModeler Premium analysis of the test Escape
